*Environmental Site Assessment
Desimone Trust Property
South Park, Seattle, Washington*

*Prepared for
Desimone Trust and
Northwest Properties Development Corporation*

*December 18, 1991
J-3329*

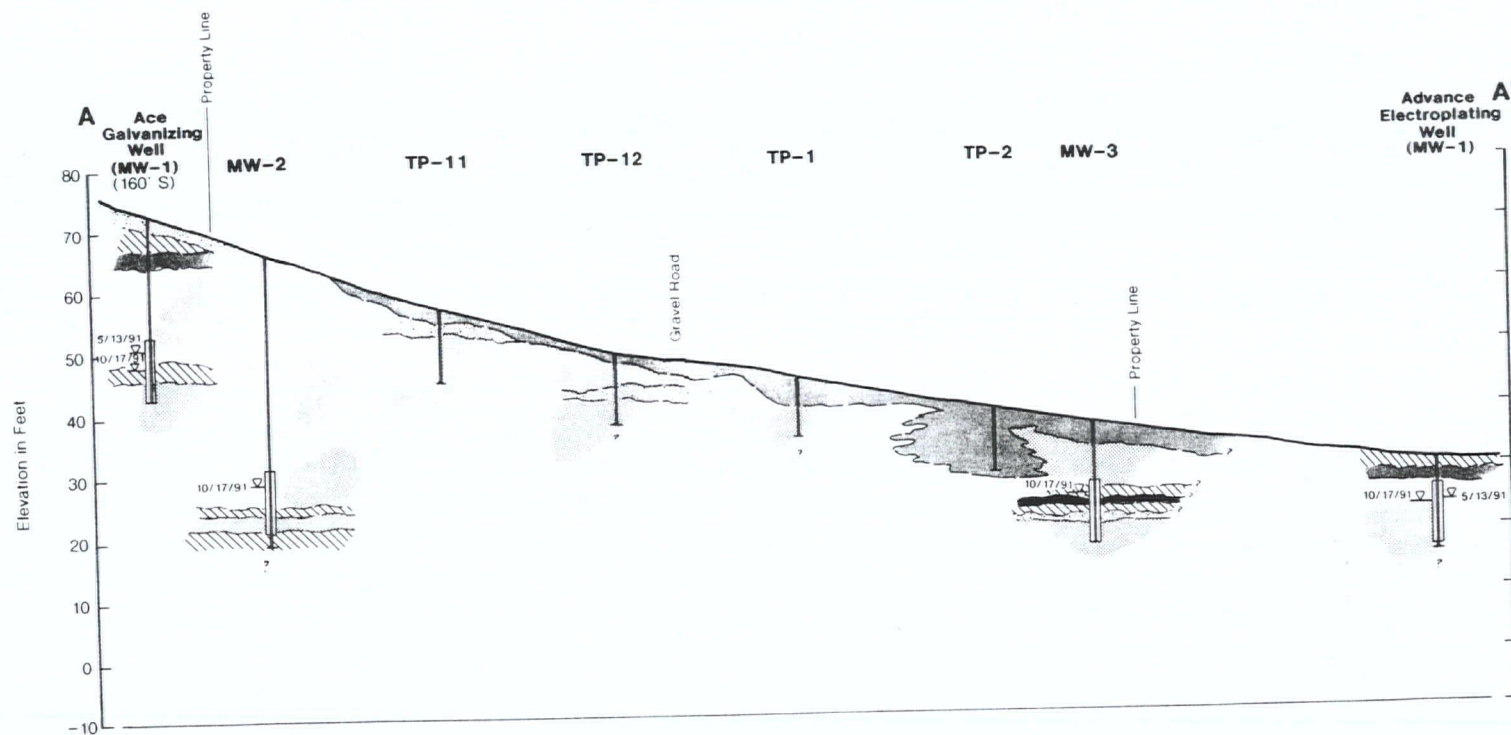
Generalized Geologic Cross Section A-A'

Soils observed at the surface on the site during drilling consisted generally of medium dense, dry, brown, silty sand to a depth of 3 to 5 feet. In the boring for MW-2, in the southwest corner of the site, a very loose, dry, brown, medium sand was observed at the surface and extended to a depth of approximately 35 feet. Below the silty sand, the soils in borings, other than MW-2, varied considerably. For more detail, see the generalized geologic cross section on Figure 2 and the boring logs on Figures A-2 through A-7 in Appendix A.

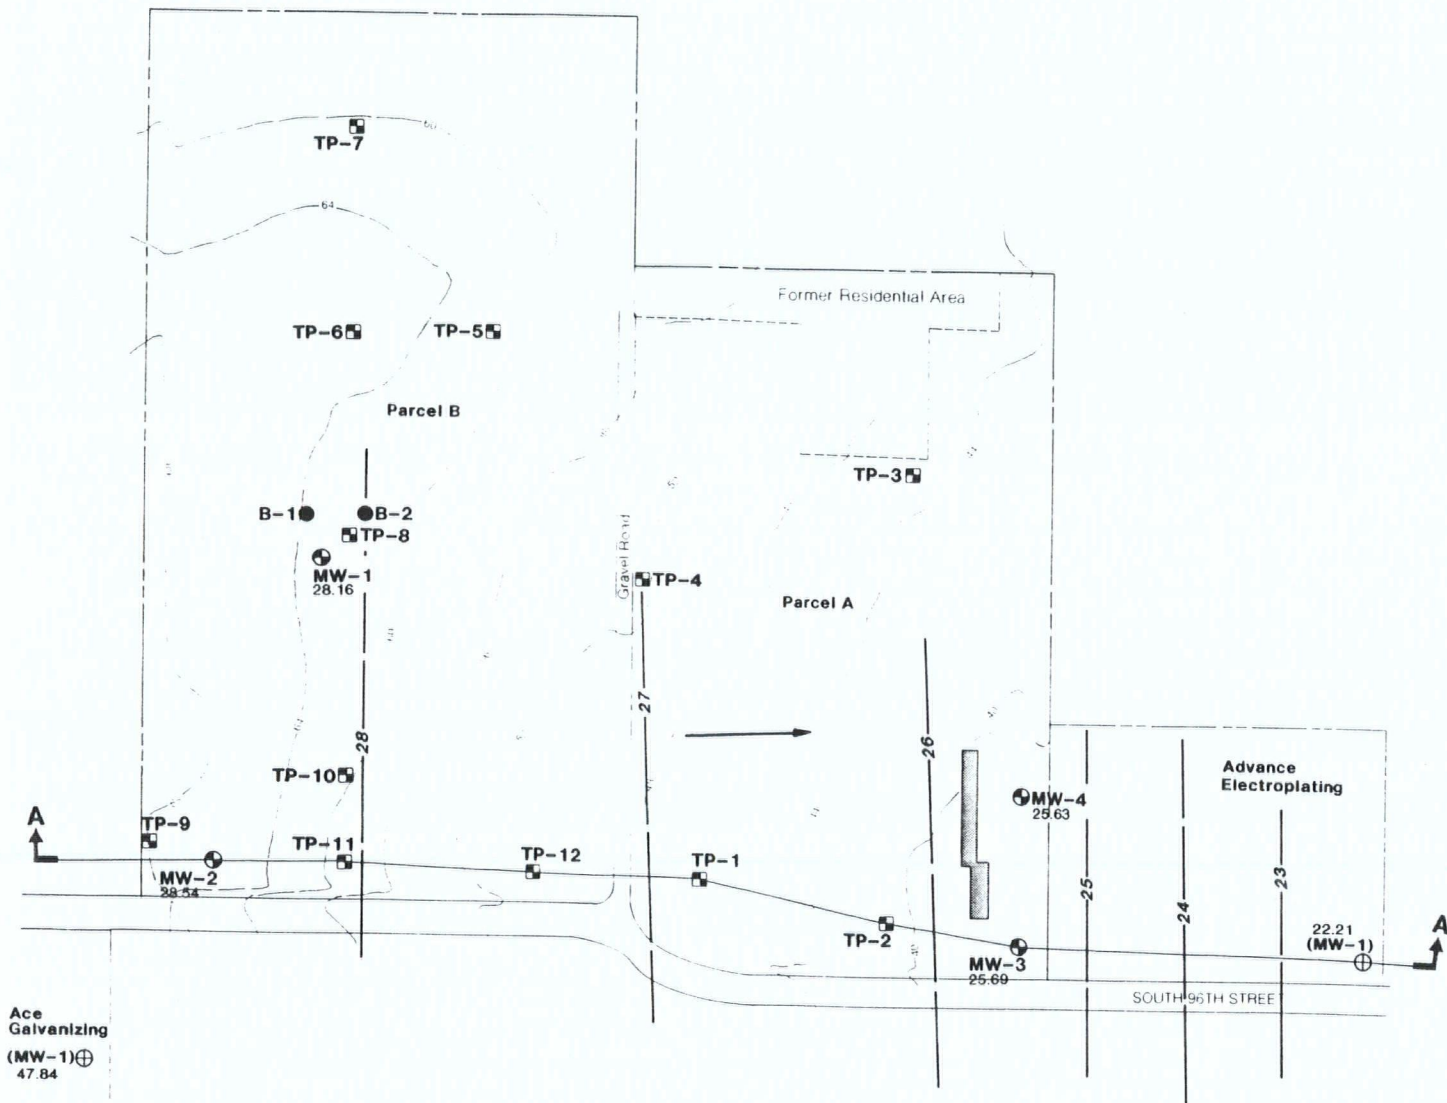
Site and Exploration Plan

Soils beneath the property are described based on the drilling and soil sampling in two soil borings and four monitoring wells. Overall, the site soils consist of predominantly sand to silty sand with interbeds of silt. The material type and the relative density suggest these are alluvial soils of the Duwamish River. The location of the borings (B-1 and B-2) and the monitoring wells (MW-1 through MW-4) are shown on Figure 1.

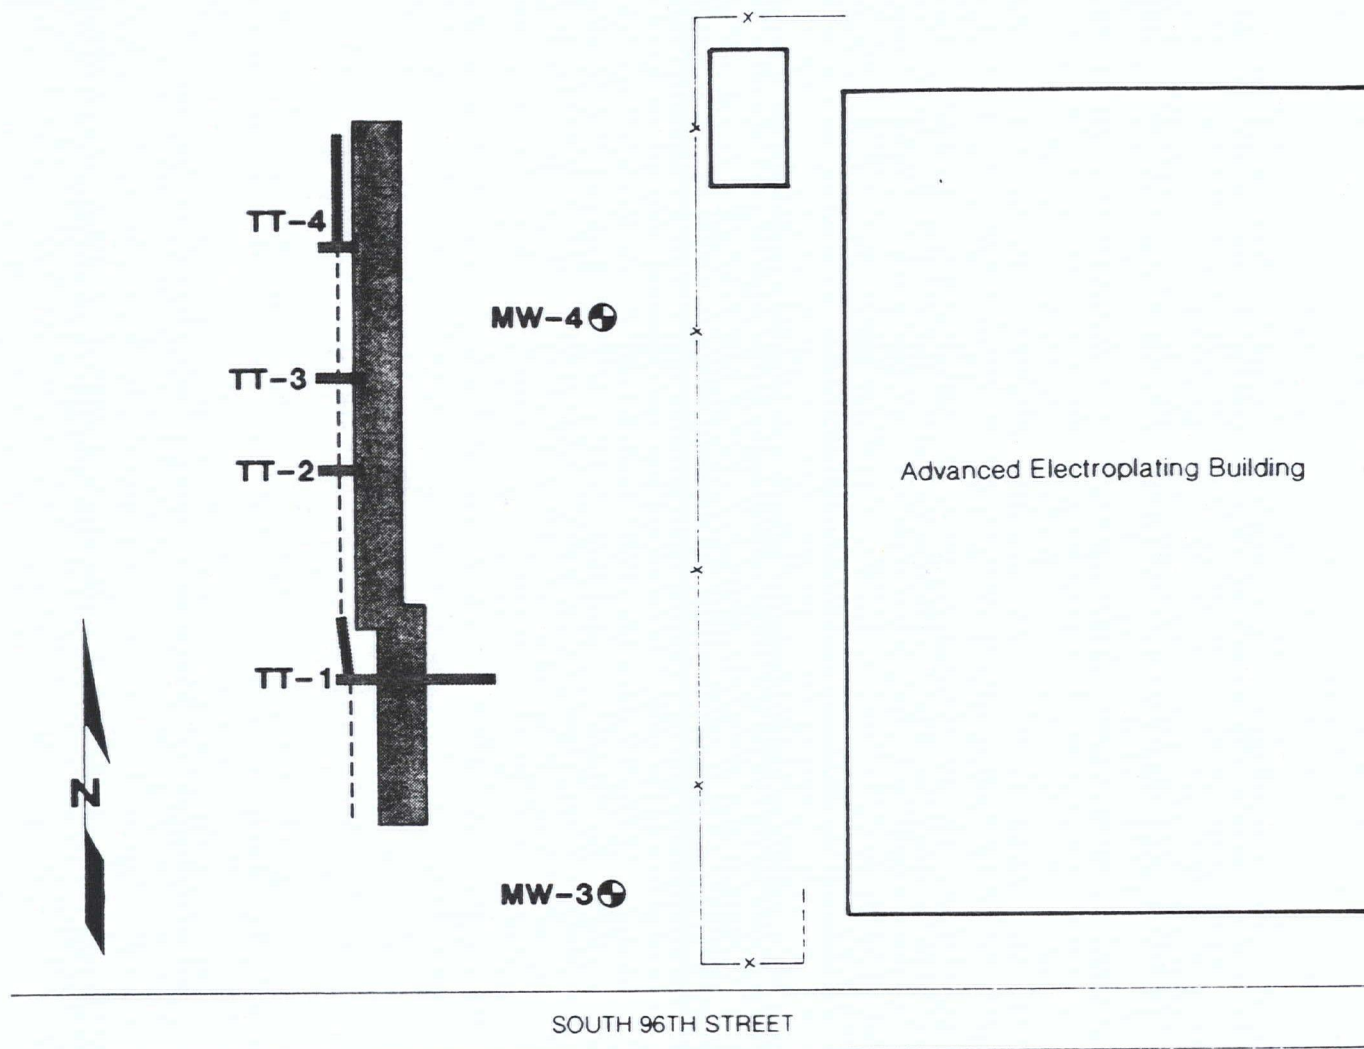
Area of Geophysical Anomaly and Test Trench Exploration Plan

Backhoe excavations performed under the supervision of Hart Crowser uncovered a 2-1/2-inch-diameter, rusted, metal irrigation pipe, along the eastern edge of Parcel A. The pipe corresponds in general to the location, shape, and size of the geophysical anomaly reported by Ecology in the Advance Electroplating site and assessment. No drums were encountered during the excavation. Figure 3 depicts the location of the geophysical anomaly, the pipe location, and our test trenches.

No buried drums were found in the area where former employees of Advance Electroplating reported them to exist. Excavations through the geophysical anomaly reported by Parametrix in the site assessment report discovered a rusted, metal irrigation line.
